# Wismut

*Landscapes designed and preserved*

June 2015

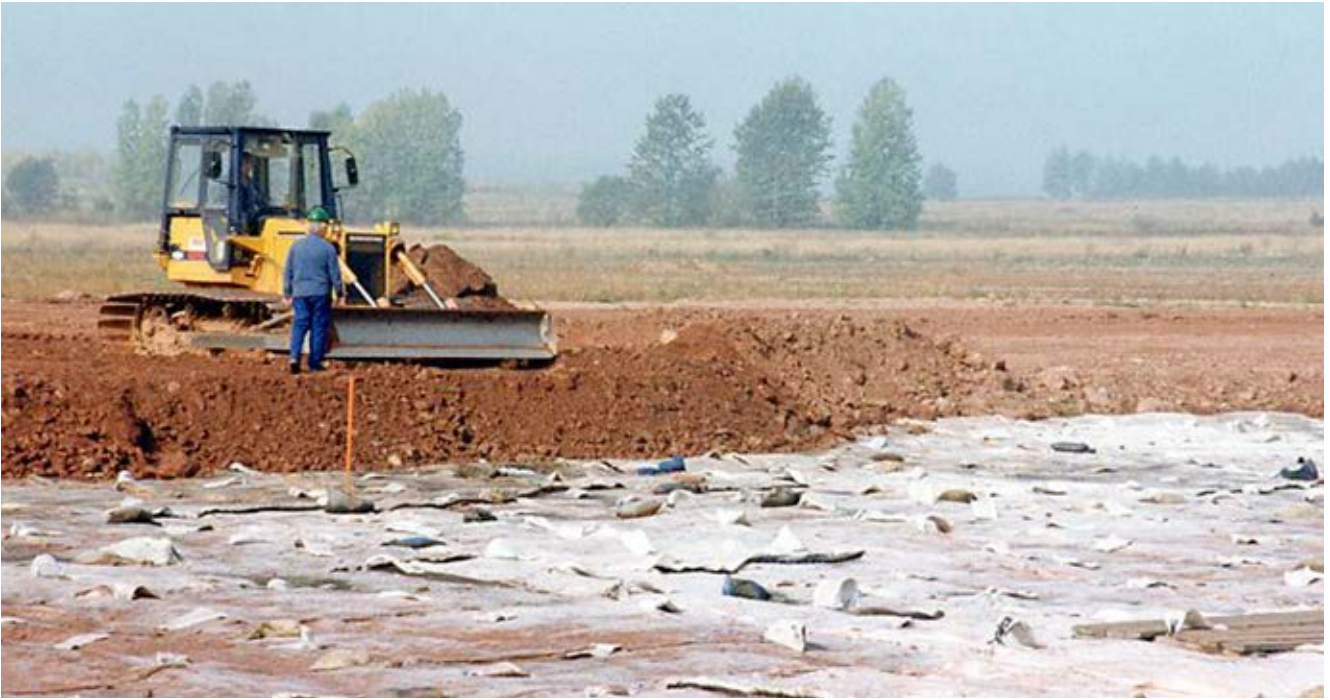
Interim covering of tailings

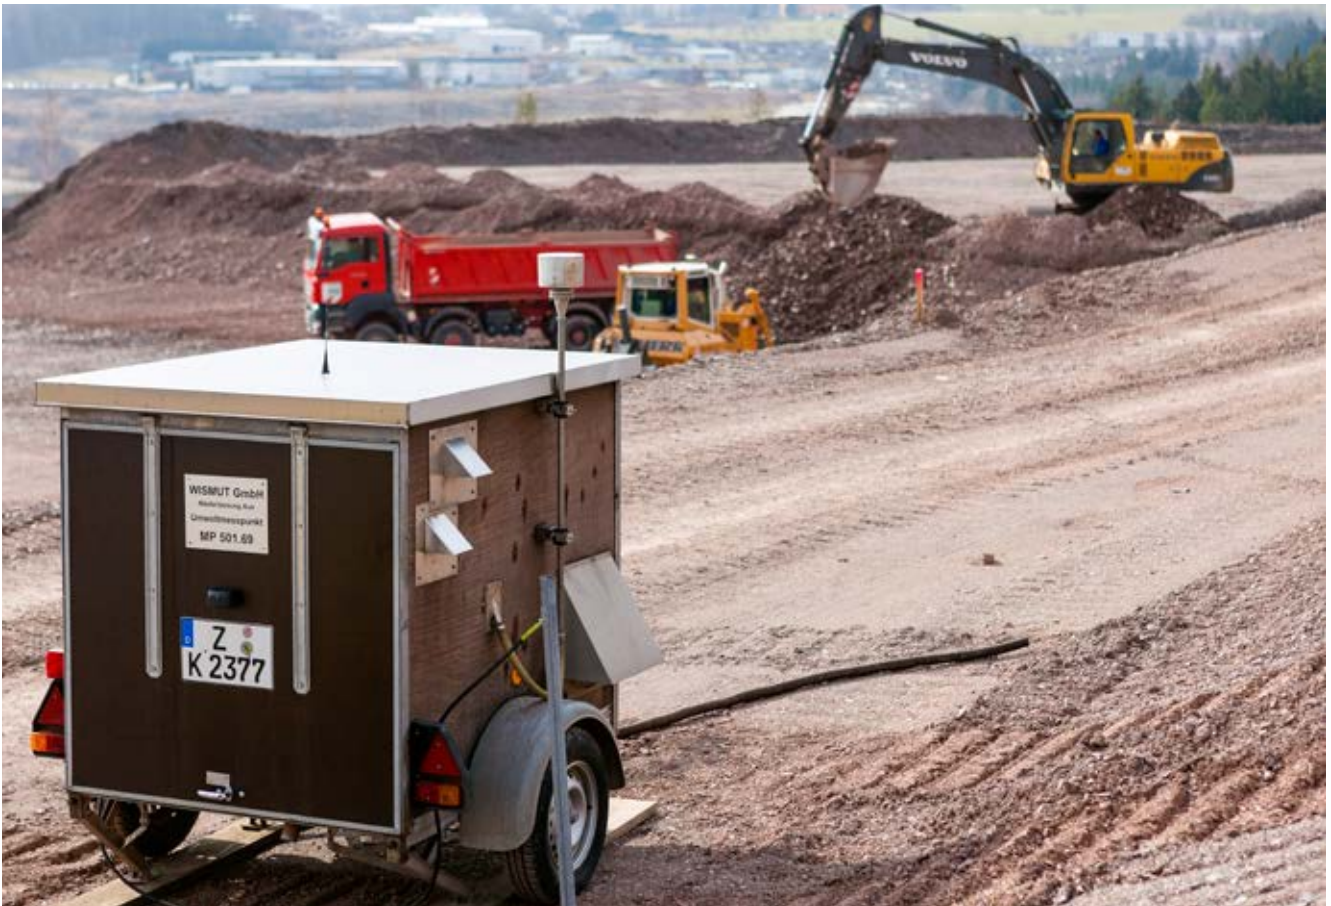
Mobile measuring station for radon and dust

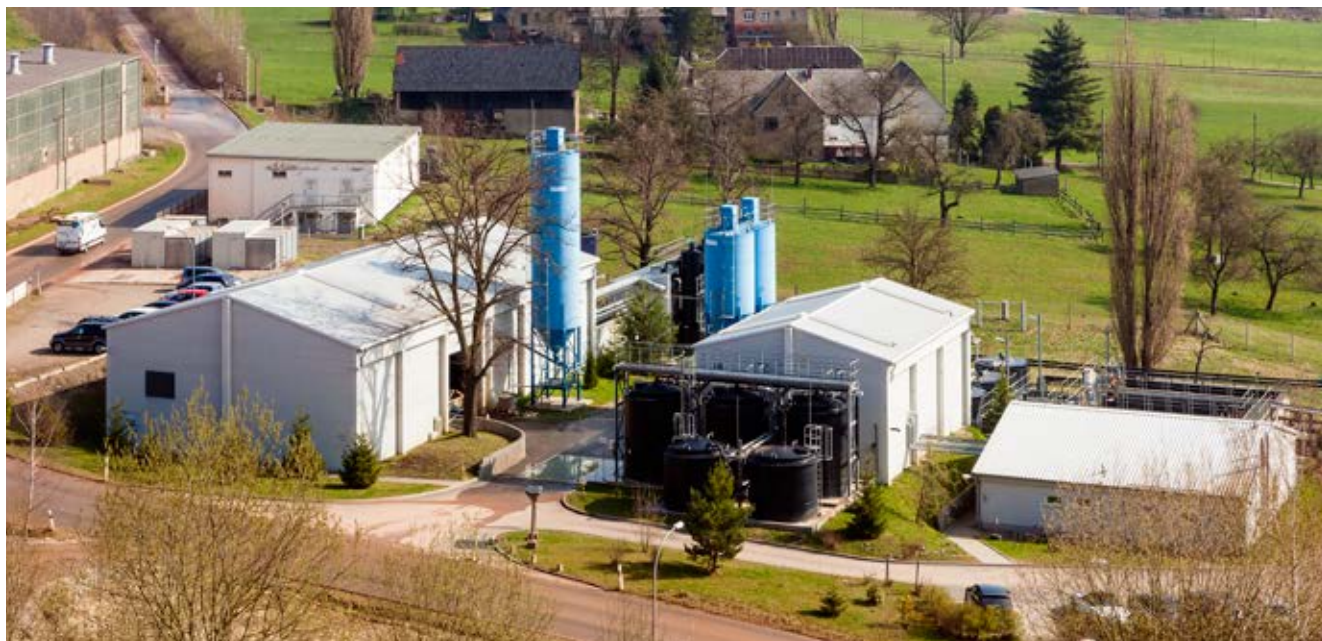
Seelingstädt water treatment plant (2011)

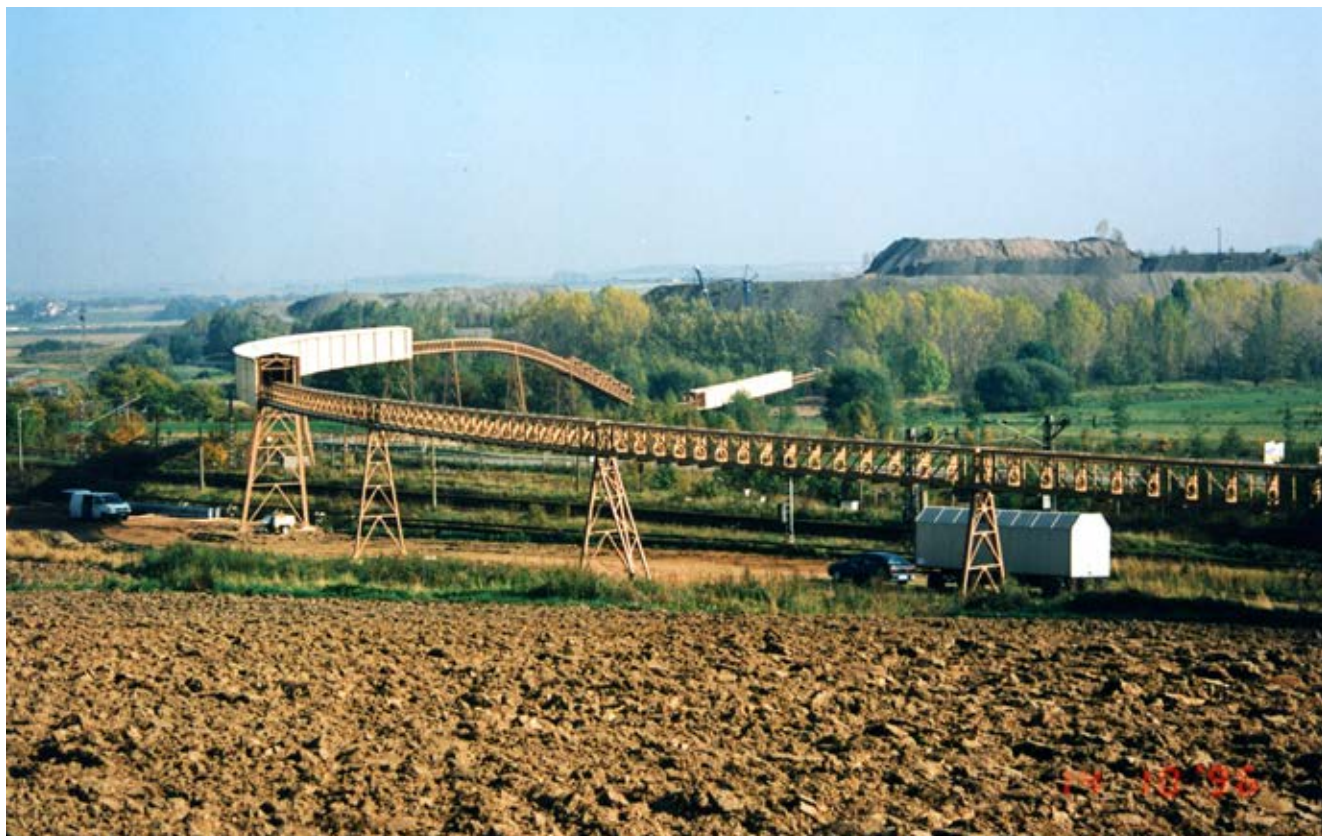
Pipe conveyor, Crossen site (1996)

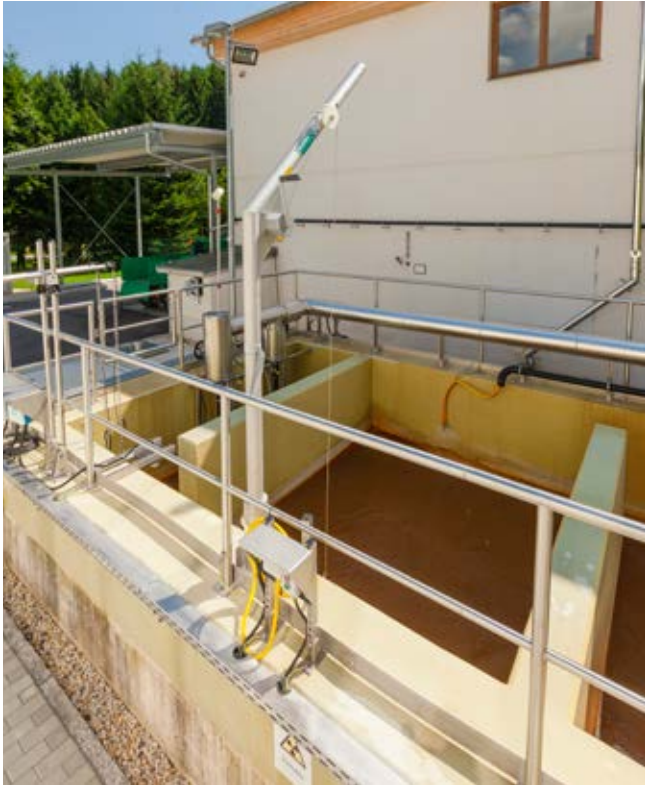
**Water treatment plant at the Pöhla site (2014)**
